ADAP-KOOL® Danbuss AK Box Code No 084B2071

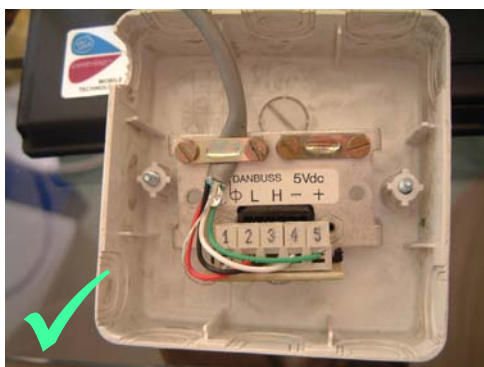
Correct Wiring

The customers were asked to change the wiring around and the system came alive and functioned correctly.

This is just to advise you if you get customers complaining that their new system will not work, or their controllers are dead, check the A K Box wiring.

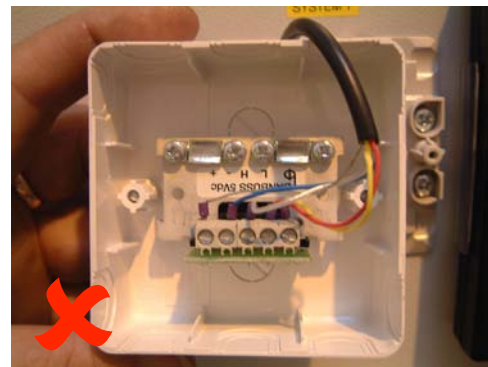
diagram had been stuck on to the board upside down. This made the wiring wrong and the Handset appeared to be dead.

As suspected the sticky wiring label had been stuck to the board upside down.

Incorrect Wiring
