Why Compressors Fail Part 7 - Failing to change compressor electrics after a burnout

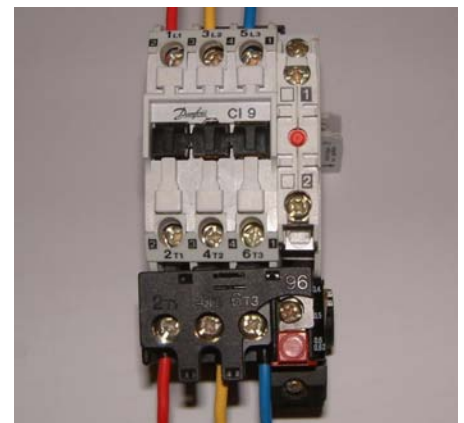
Contactor and Overload relay for 3-phase system

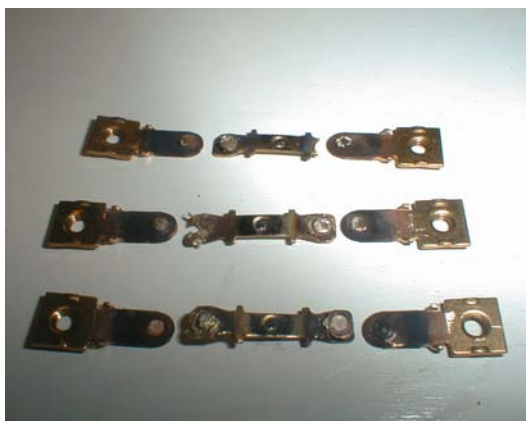
Here we can see the type of damage that has occurred to the contacts inside the contactor after a compressor failure.

It is often the case that after a compressor failure the contactor itself is also damaged. This will result in the contactor either not working at all or not working correctly. In this situation some engineers have condemned the new compressor has being DOA (Dead On Arrival) or the new compressor has been fitted and then suffered catastrophic damage and itself needed replacing.

The problem was simply that the engineer had not changed or inspected the compressor contactor. The contactor had no overload fitted and the contactor's contacts had partially melted away during the original compressor burn out. When the new compressor was fitted the compressor ran but was only running on 2

phases instead of the designed 3 phases due to one contact leg making little or NO contact.

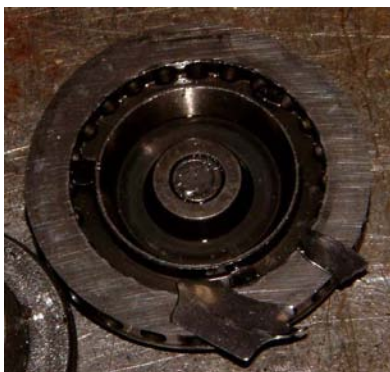
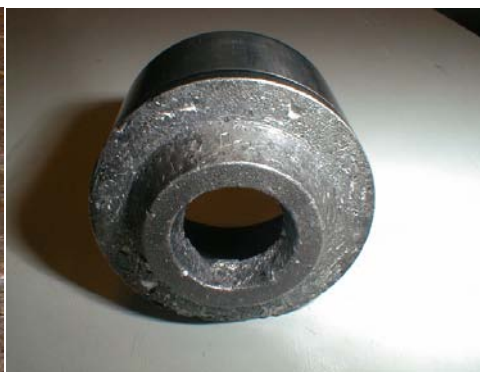
these two compressors were cut open it was found that the suction valve was smashed and the centre of the piston had a large hole through it, therefore, the compressor was unable to pump. All other components of the compressor were in mint condition.

In the first picture we can see where the valve has been smashed and in this case pieces are embedded into the valve plate. The second picture is typical of the damage that is caused when pieces of the valve fall into the cylinder. This type of damage is caused when the compressor tries to pump liquid refrigerant.

This caused the compressor to trip on its internal klixon. The system was still calling for duty and consequently the liquid valve was still energised. This allowed the system charge to migrate from the condenser/receiver and into the evaporator and the compressor. Whilst the compressor was in the tripped condition, liquid refrigerant was running uncontrolled into the compressor shell. When the klixon eventually reset itself, the compressor re-started and then tried to pump on the liquid refrigerant that had filled the compressor. This caused the suction valve to break and fall into the cylinder bore and onto the piston. As the piston travelled back up the cylinder the valve plate was compressed between the piston crown and the discharge valve assembly. This caused the piston crown to smash and a hole through the piston was the result.

On running the compressor and quickly measuring the phase loadings, the problem was quickly confirmed. The contactor was replaced along with an overload which was connected through the control circuit, and the plant test run. All phase loadings were now equal and the compressor operated and cut out on temperature correctly. No further problems occurred on this site.

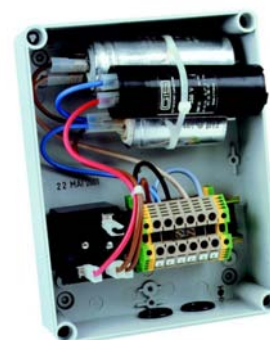
*Single phase starter kit.
This should always be replaced when fitting a new compressor.*

On single phase machines where start capacitors and relays are involved, always replace the electrics when fitting a new compressor as a faulty relay or capacitor could quickly burn out the start winding on a replacement machine in a matter of seconds.

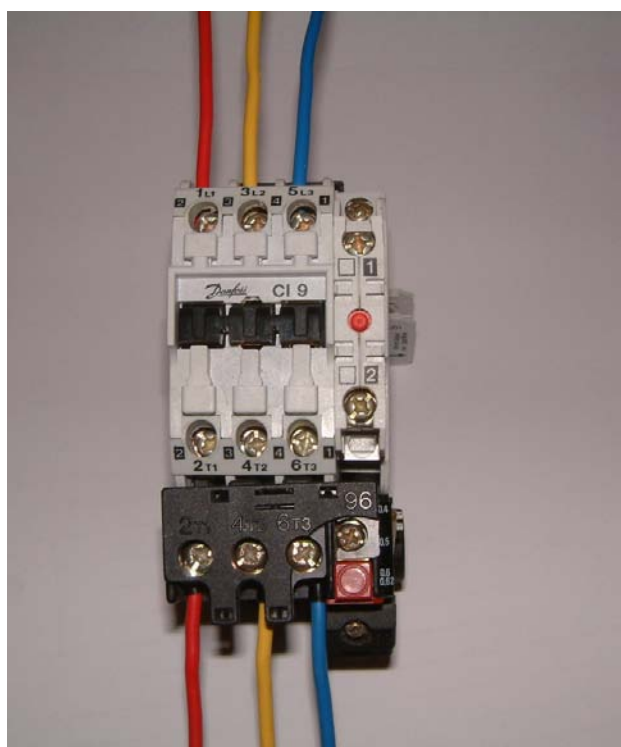
3-Phase.

3-Phase
This contactor is wired to the older UK standard, however, it still illustrates the correct wiring of the 3-phases. With the new European standard the Red wire would be replaced with a Brown wire, the Yellow wire would be replaced with a Black wire and the Blue wire would be replaced with a Grey wire.

It is important to not only replace the contactor and overload protector after a compressor failure but you should also ensure that they are wired correctly into the electrical control circuit, below we have a couple of photo's showing the correct wiring for both 3-phase systems and a single phase system using a 3-phase contactor.
