ADAP-KOOL® Danbuss AK Box Code No 084B2071

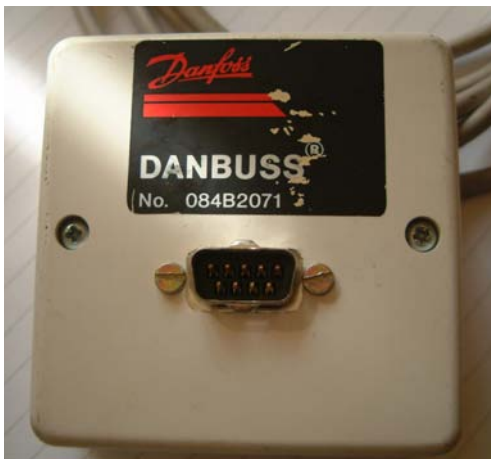
The customers were asked to check the access box connections because about 2 years ago we had a batch of A K Boxes where the electrical wiring

diagram had been stuck on to the board upside down. This made the wiring wrong and the Handset appeared to be dead.

As suspected the sticky wiring label had been stuck to the board upside down.

The customers were asked to change the wiring around and the system came alive and functioned correctly.

This is just to advise you if you get customers complaining that their new system will not work, or their controllers are dead, check the A K Box wiring.
